Maryland Inventory of Historic Properties Number: CAR-299

Name: #CO-0027/Double Hill Rd over Watts Creek

MARYLAND INVENTORY OF HISTORIC BRIDGES  
HISTORIC BRIDGE INVENTORY  
MARYLAND STATE HIGHWAY ADMINISTRATION/  
MARYLAND HISTORICAL TRUST

SHA Bridge No. C-0027 Bridge name Double Hill Road over Watts Creek

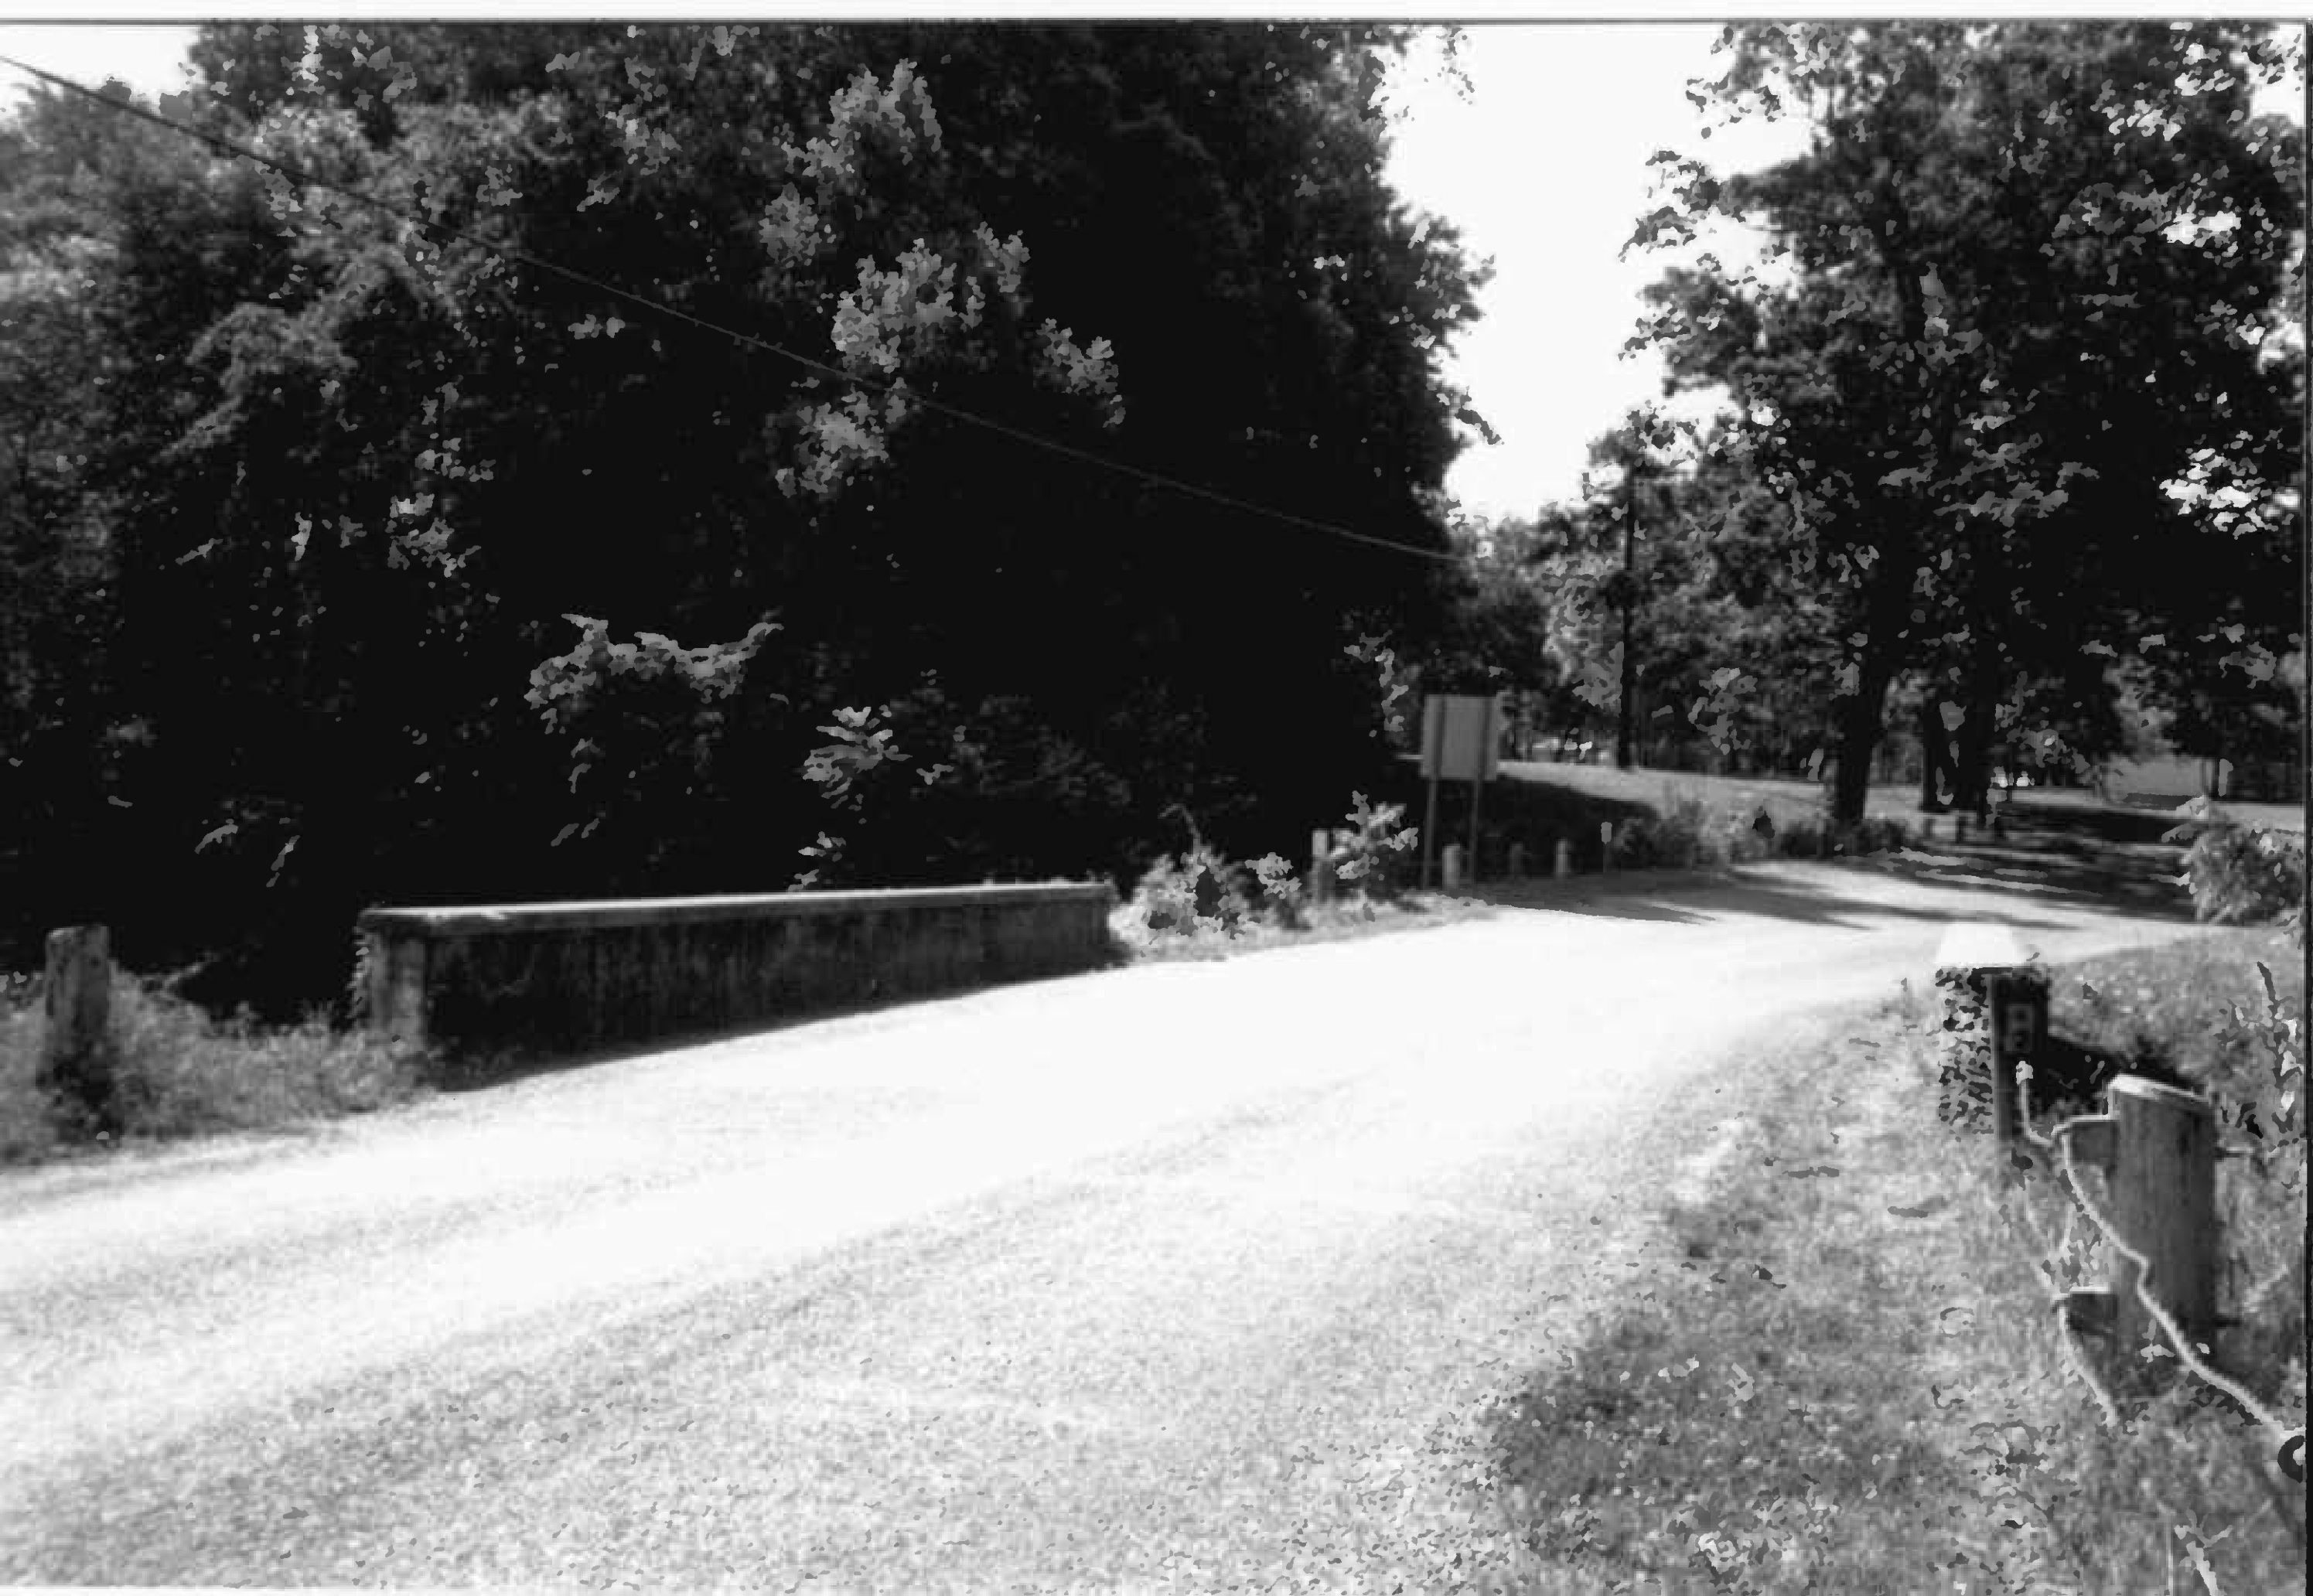
1. CAR-299
2. DOUBLE HILL ROAD OVER WATTS CREEK
3. CAROLINE Co., MD
4. CAROLINE HALL
5. JUNE 1997
6. MD SHPO
7. SOUTHEAST VIEW OF ROADWAY APPROACH
8. 1 OF 6

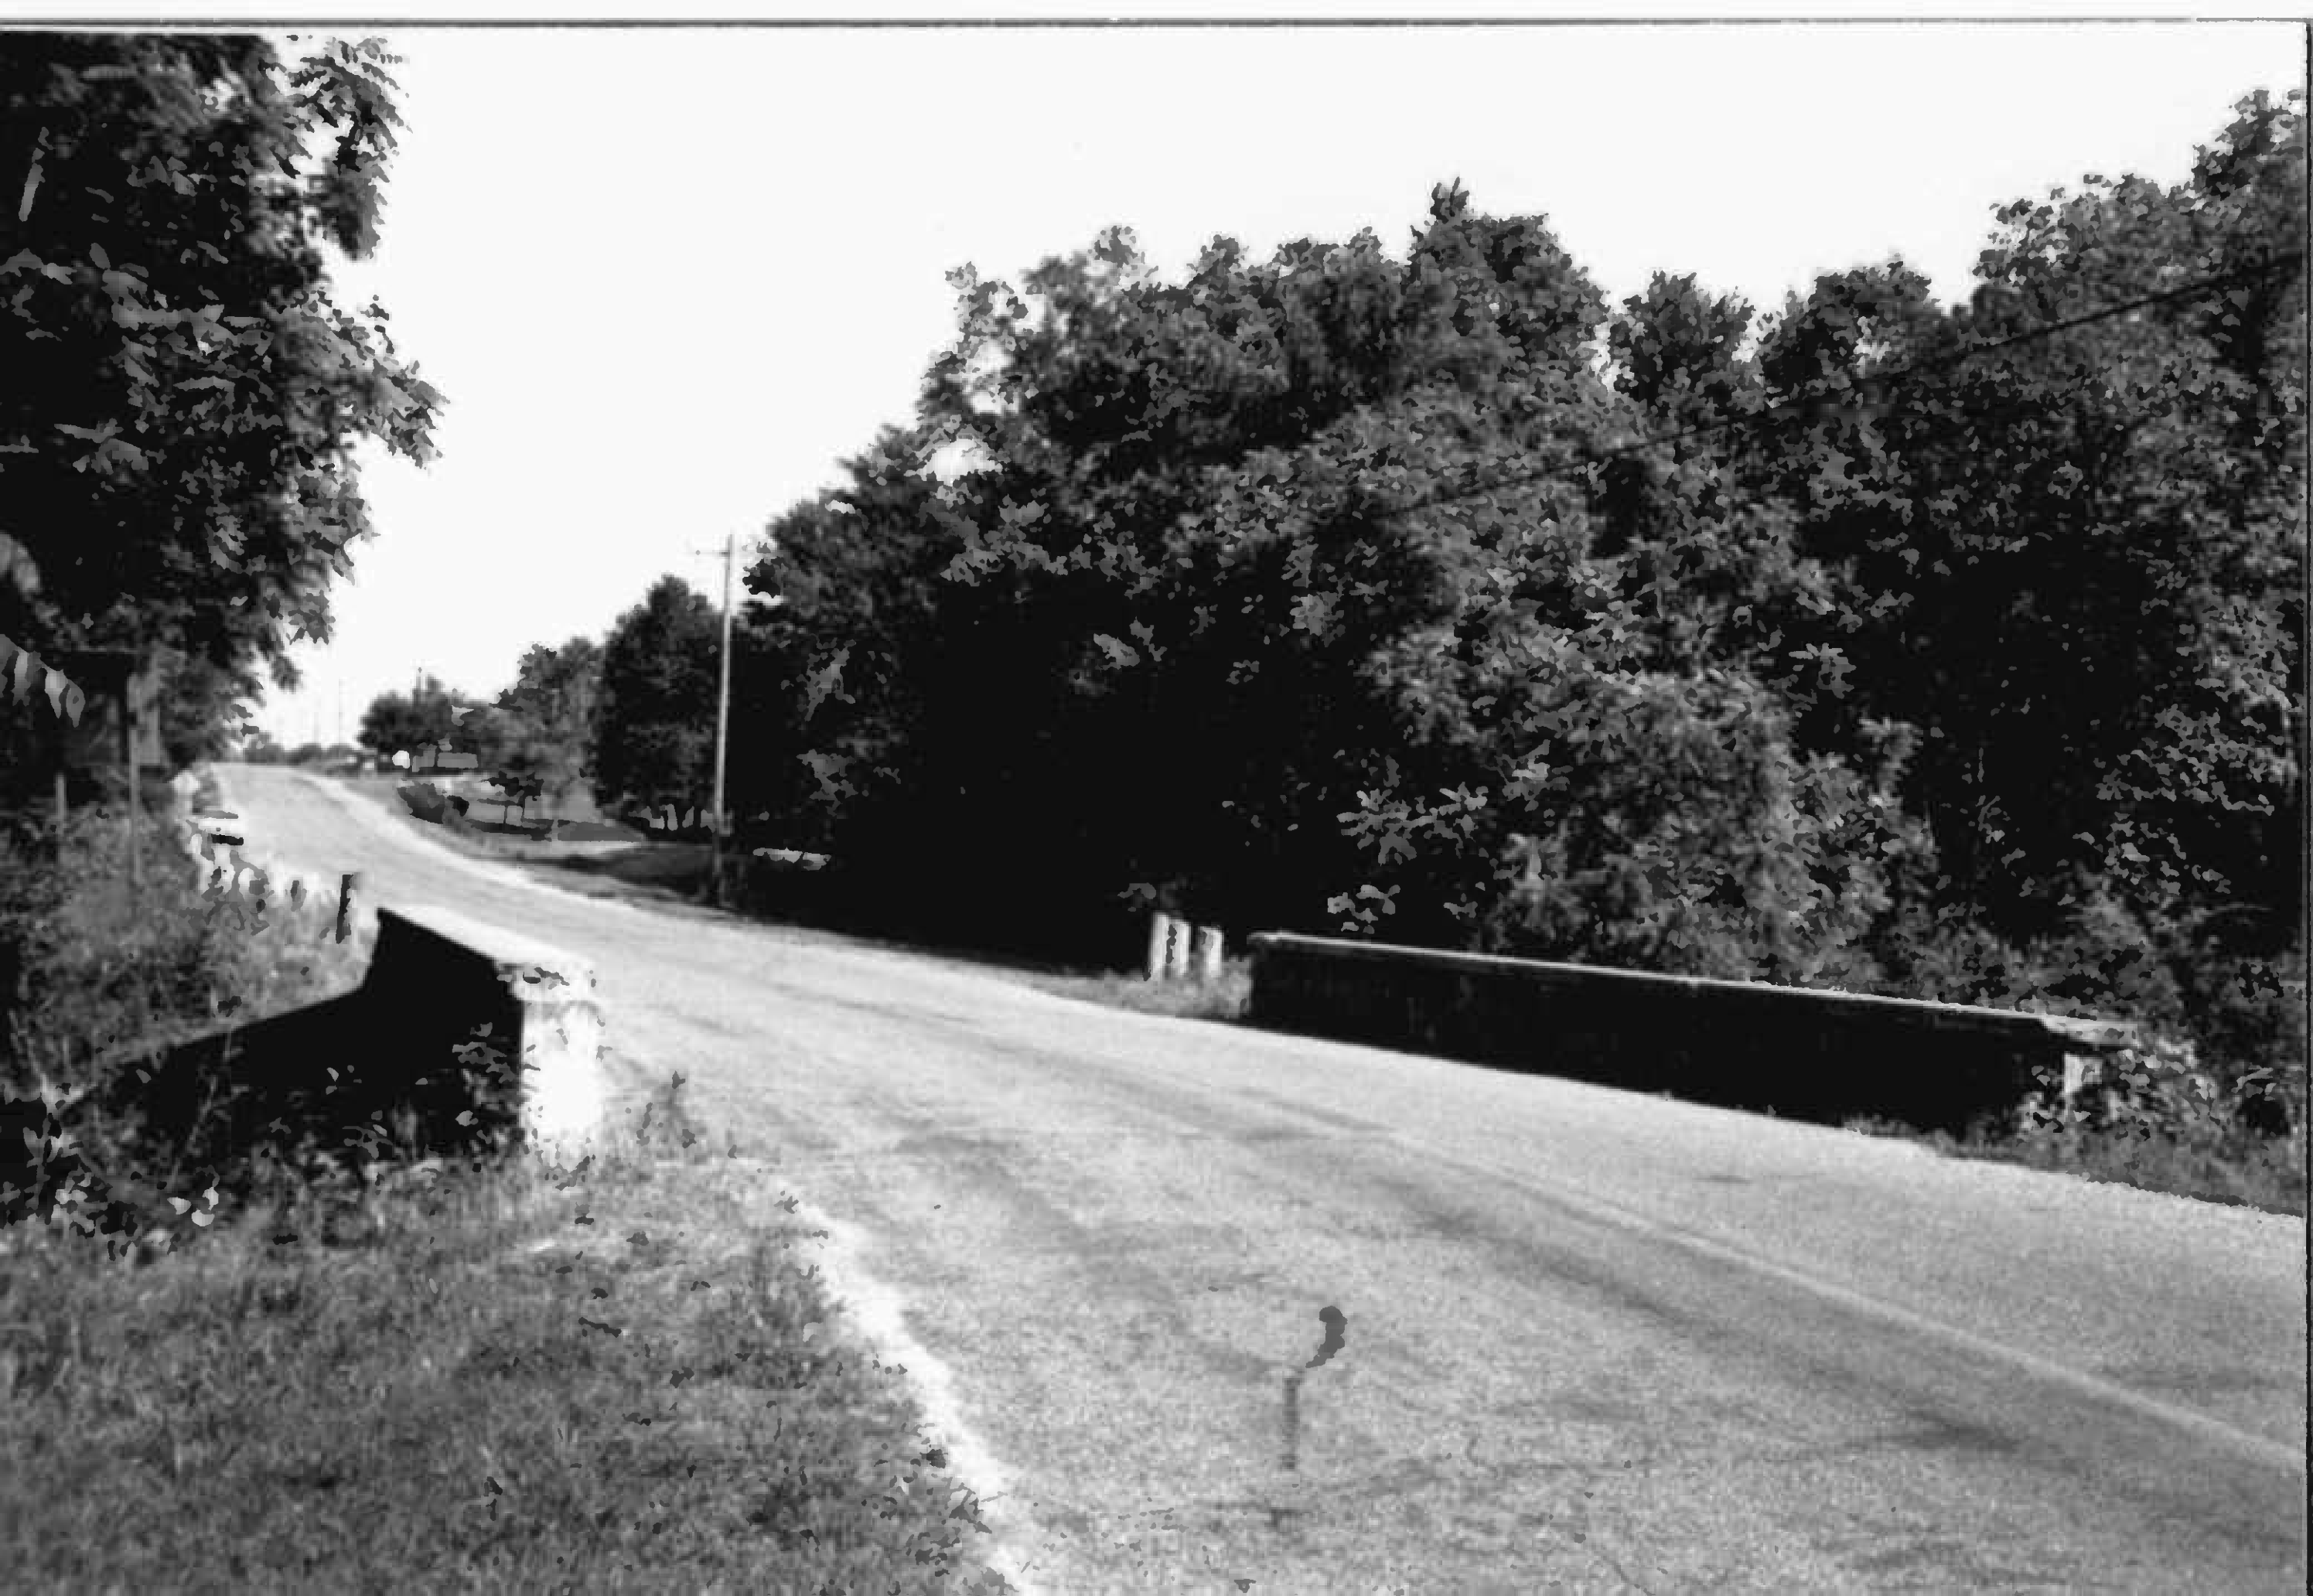
1. CAR-299
2. DOUBLE HILL ROAD OVER WATTS CREEK
3. CAROLINE CO., MD
4. CAROLINE HALL
5. JUNE 1997
6. MD SHPO
7. NORTHWEST VIEW OF ROADWAY APPROACH
8. 2 OF 6

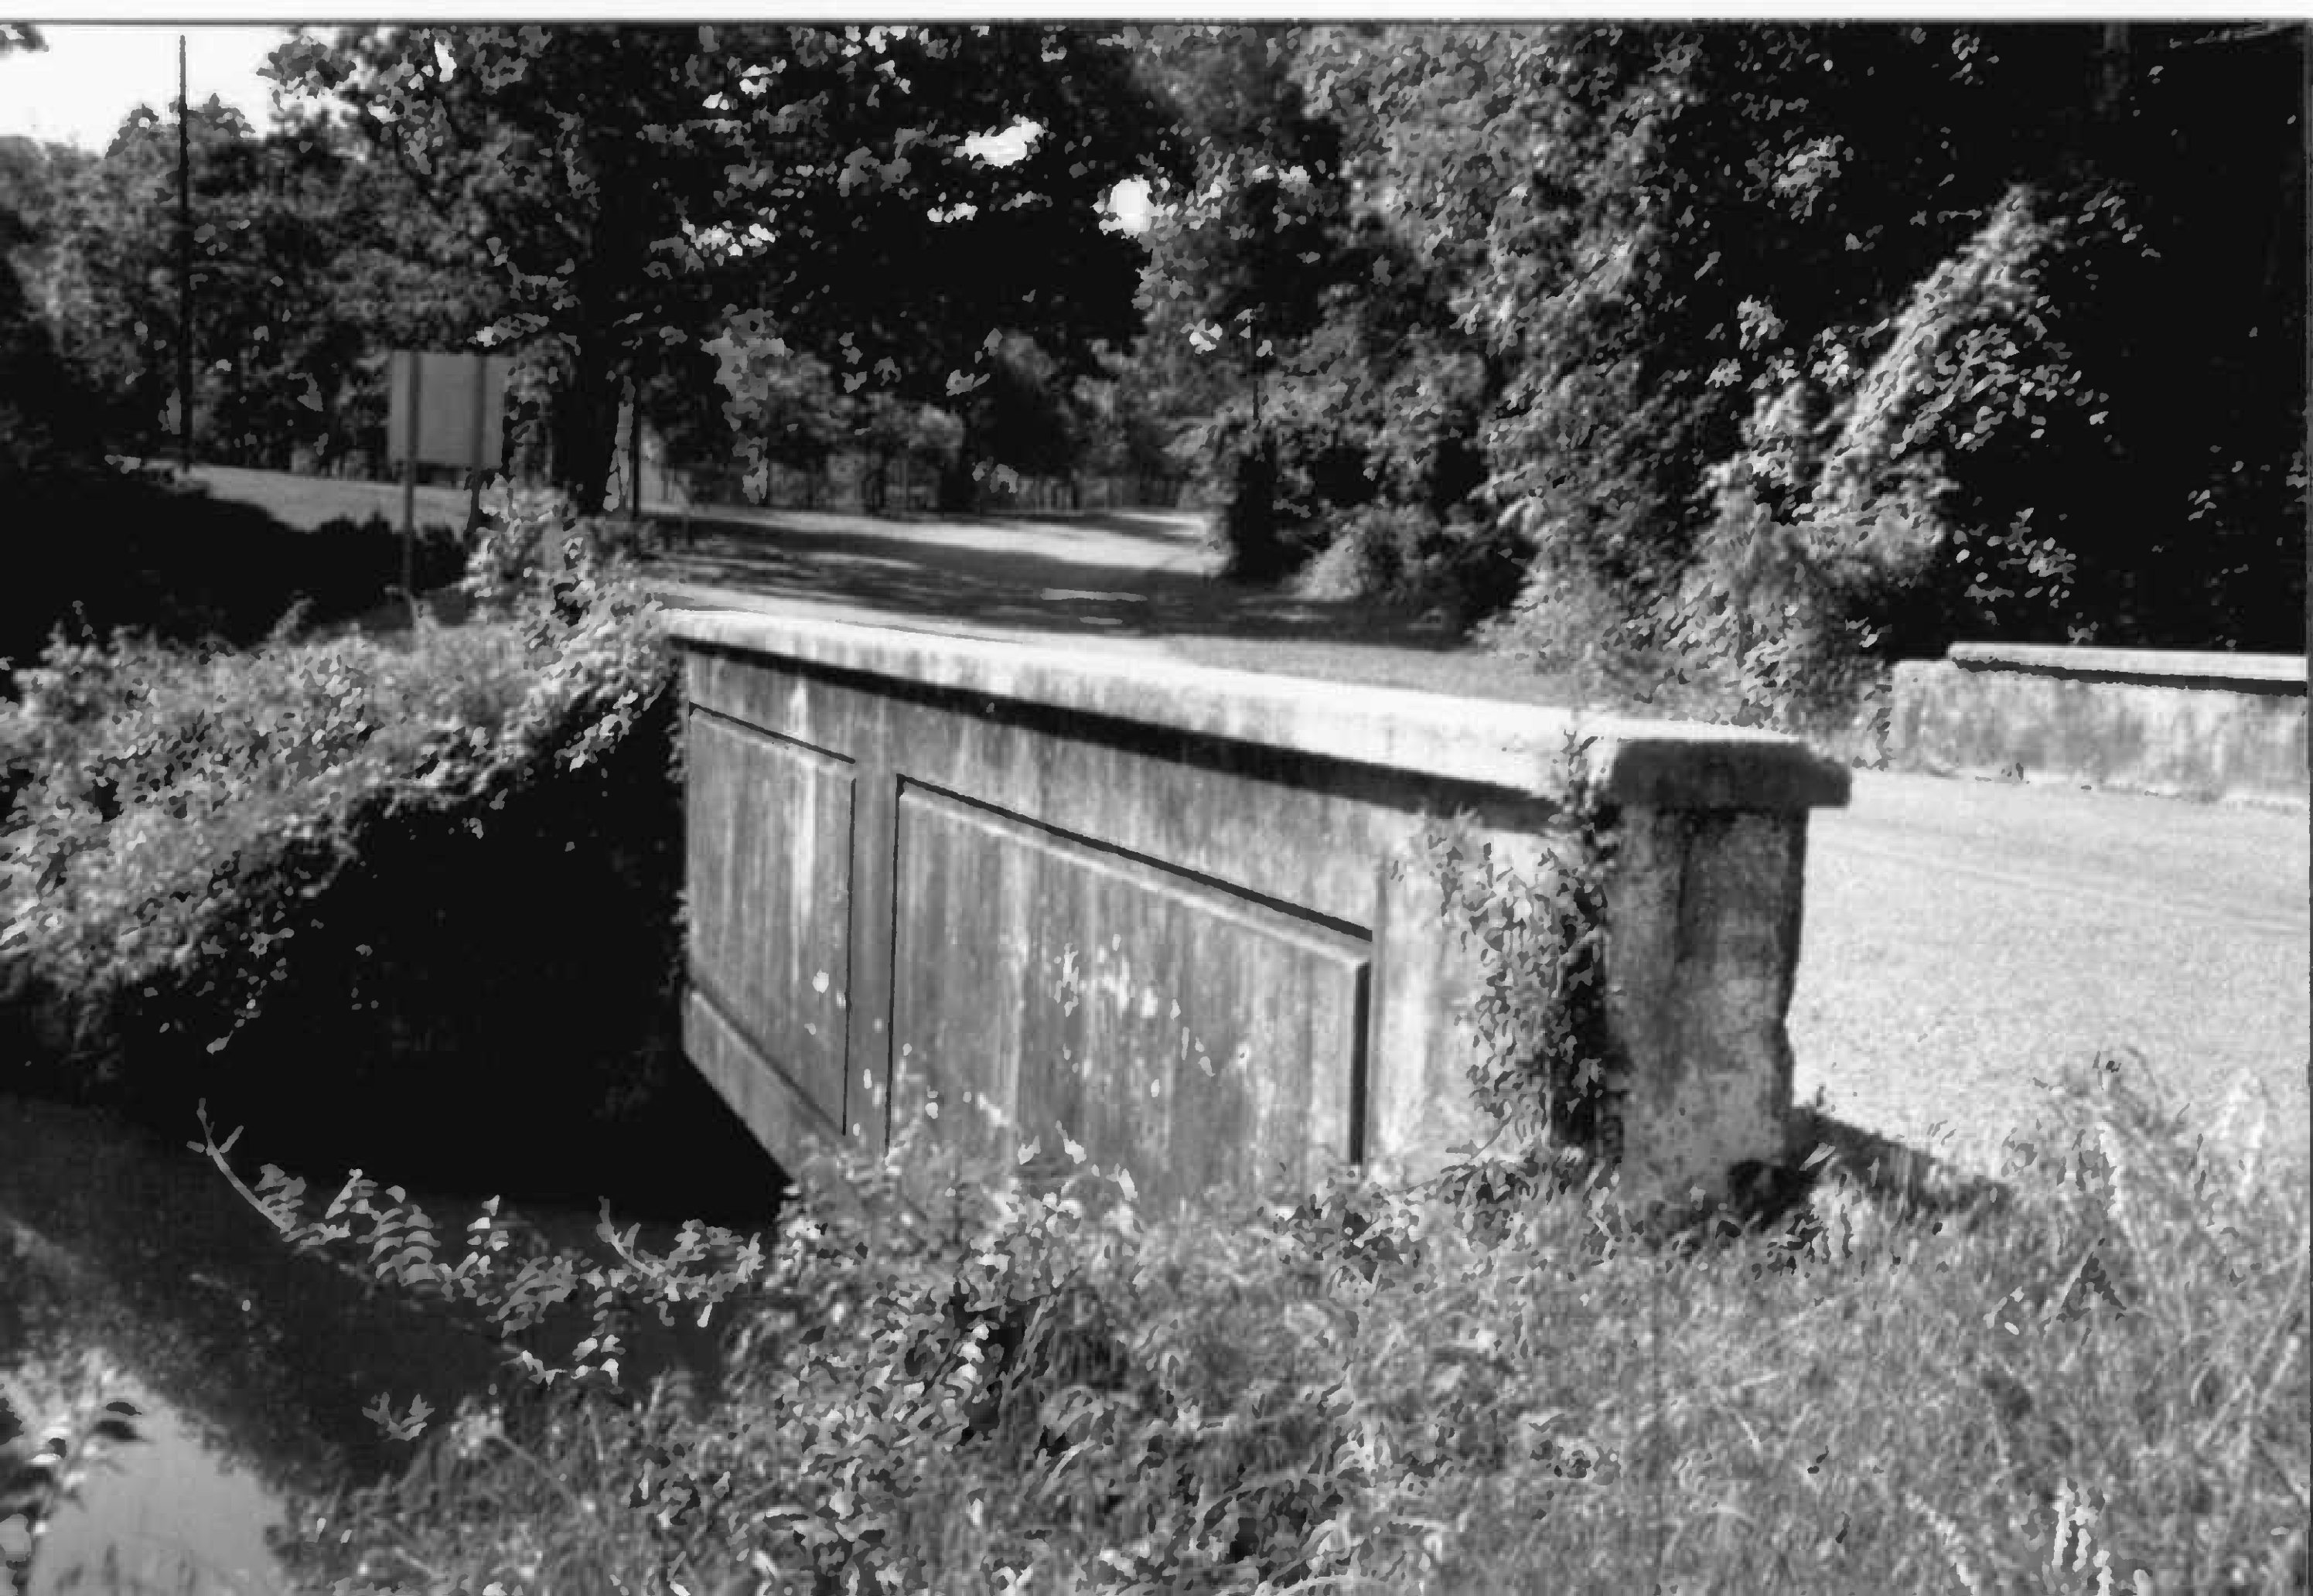
1. CAR-299
2. DOUBLE HILL ROAD OVER WATTS CREEK
3. CAROLINE CO., MD
4. CAROLINE HALL
5. JUNE 1997
6. MD SHPO
7. SOUTHEAST PARAPET WALL
8. 4 OF 6

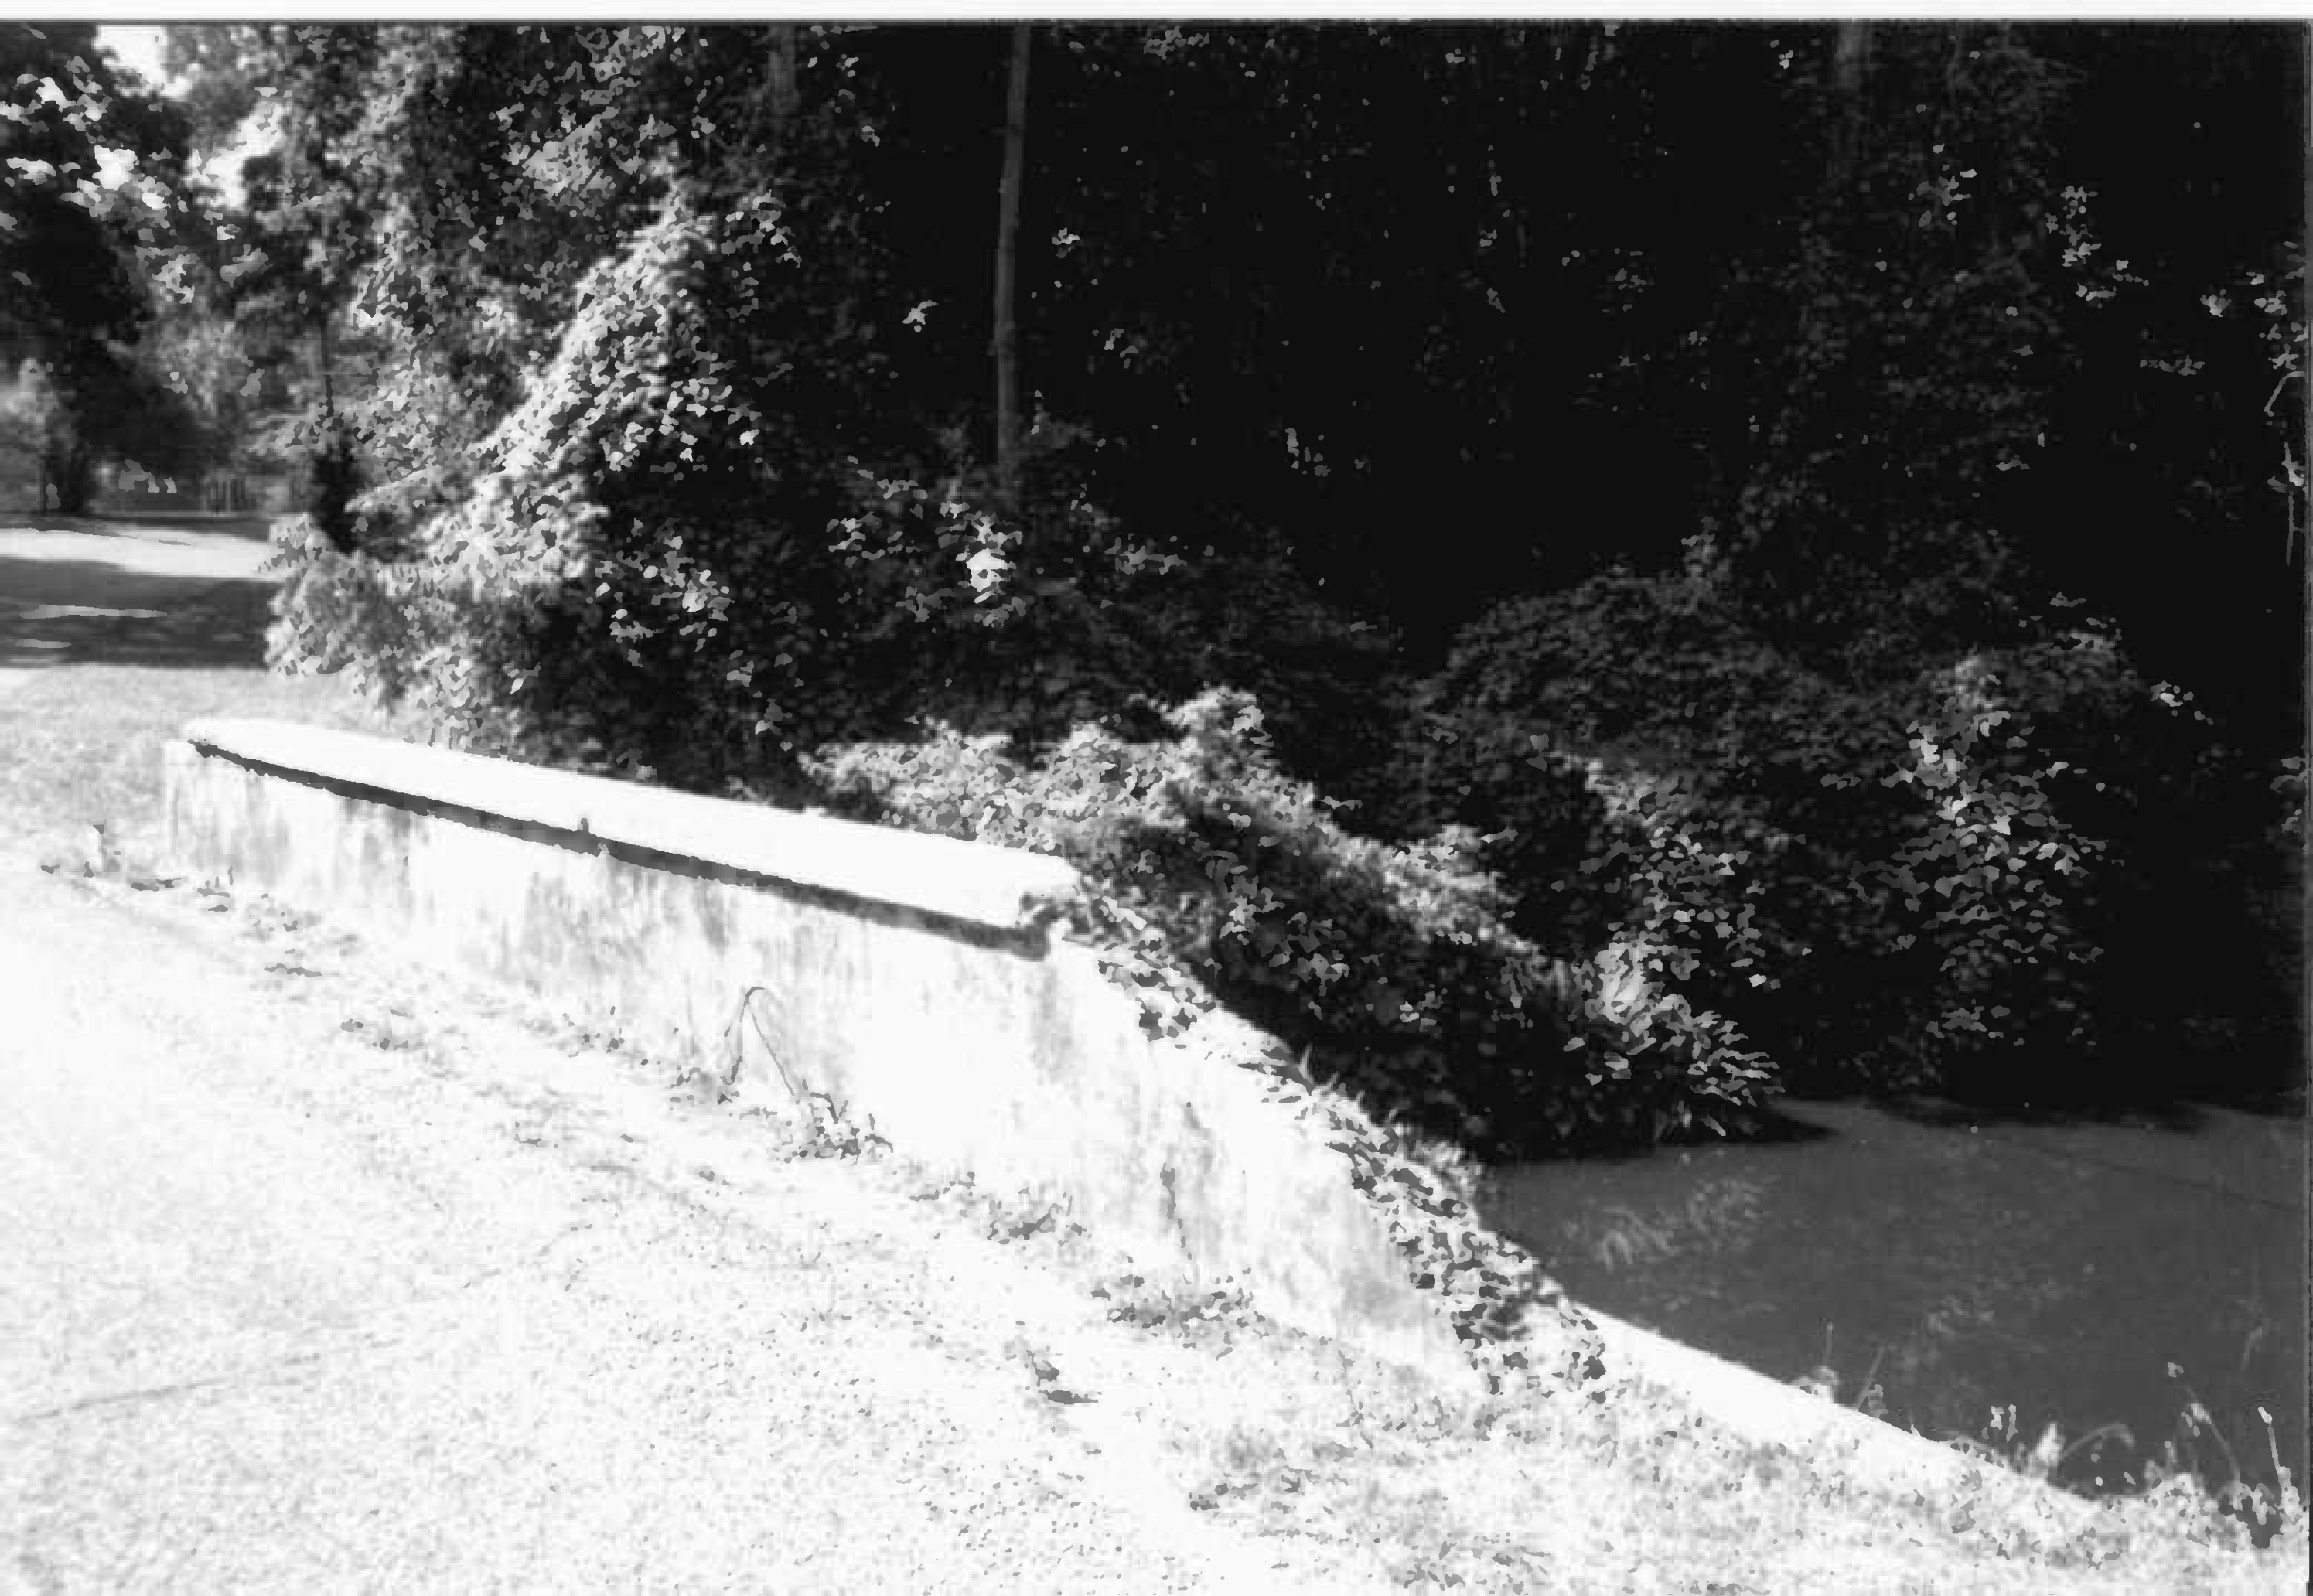
According to the 1995 inspection report (inspection conducted in February and April of 1996), this structure is in fair condition. The asphalt wearing surface is cracking along the parapets and has transverse and longitudinal cracks over the abutments. The concrete beams are moderately spalled and cracked with exposed reinforcing bars and the concrete abutments are spalled and cracked. The wingwalls have cracking and scaling at the waterline. The concrete parapets are in poor condition, as a 5 foot long section at the north end of the west parapet is broken and the west parapet cap at the south abutment is also broken. In addition, the exterior downstream face of the west parapet has a full-length crack with efflorescence at the intersection of the parapet and the concrete deck.

A significant example of a concrete beam bridge should possess character-defining elements of its type, and be readily recognizable as an historic structure from the perspective of the traveler. The integrity of distinctive features visible from the roadway approach, including parapet walls or railings, is important in structures which are common examples of their type. In addition, the structure must be in excellent condition. This parapet walls of this bridge are damaged and deteriorated, including the loss of a 5 foot section of the west parapet, and therefore, Bridge C-0027 is an undistinguished example of a concrete beam bridge.

1. CAR-299
2. DOUBLE HILL ROAD OVER WATTS CREEK
3. CAROLINE CO., MD
4. CAROLINE HALL
5. JUNE 1997
6. MD SHPO
7. SOUTHEAST DETERIORATION ON SOUTH BARADDET
8. 5 OF 6

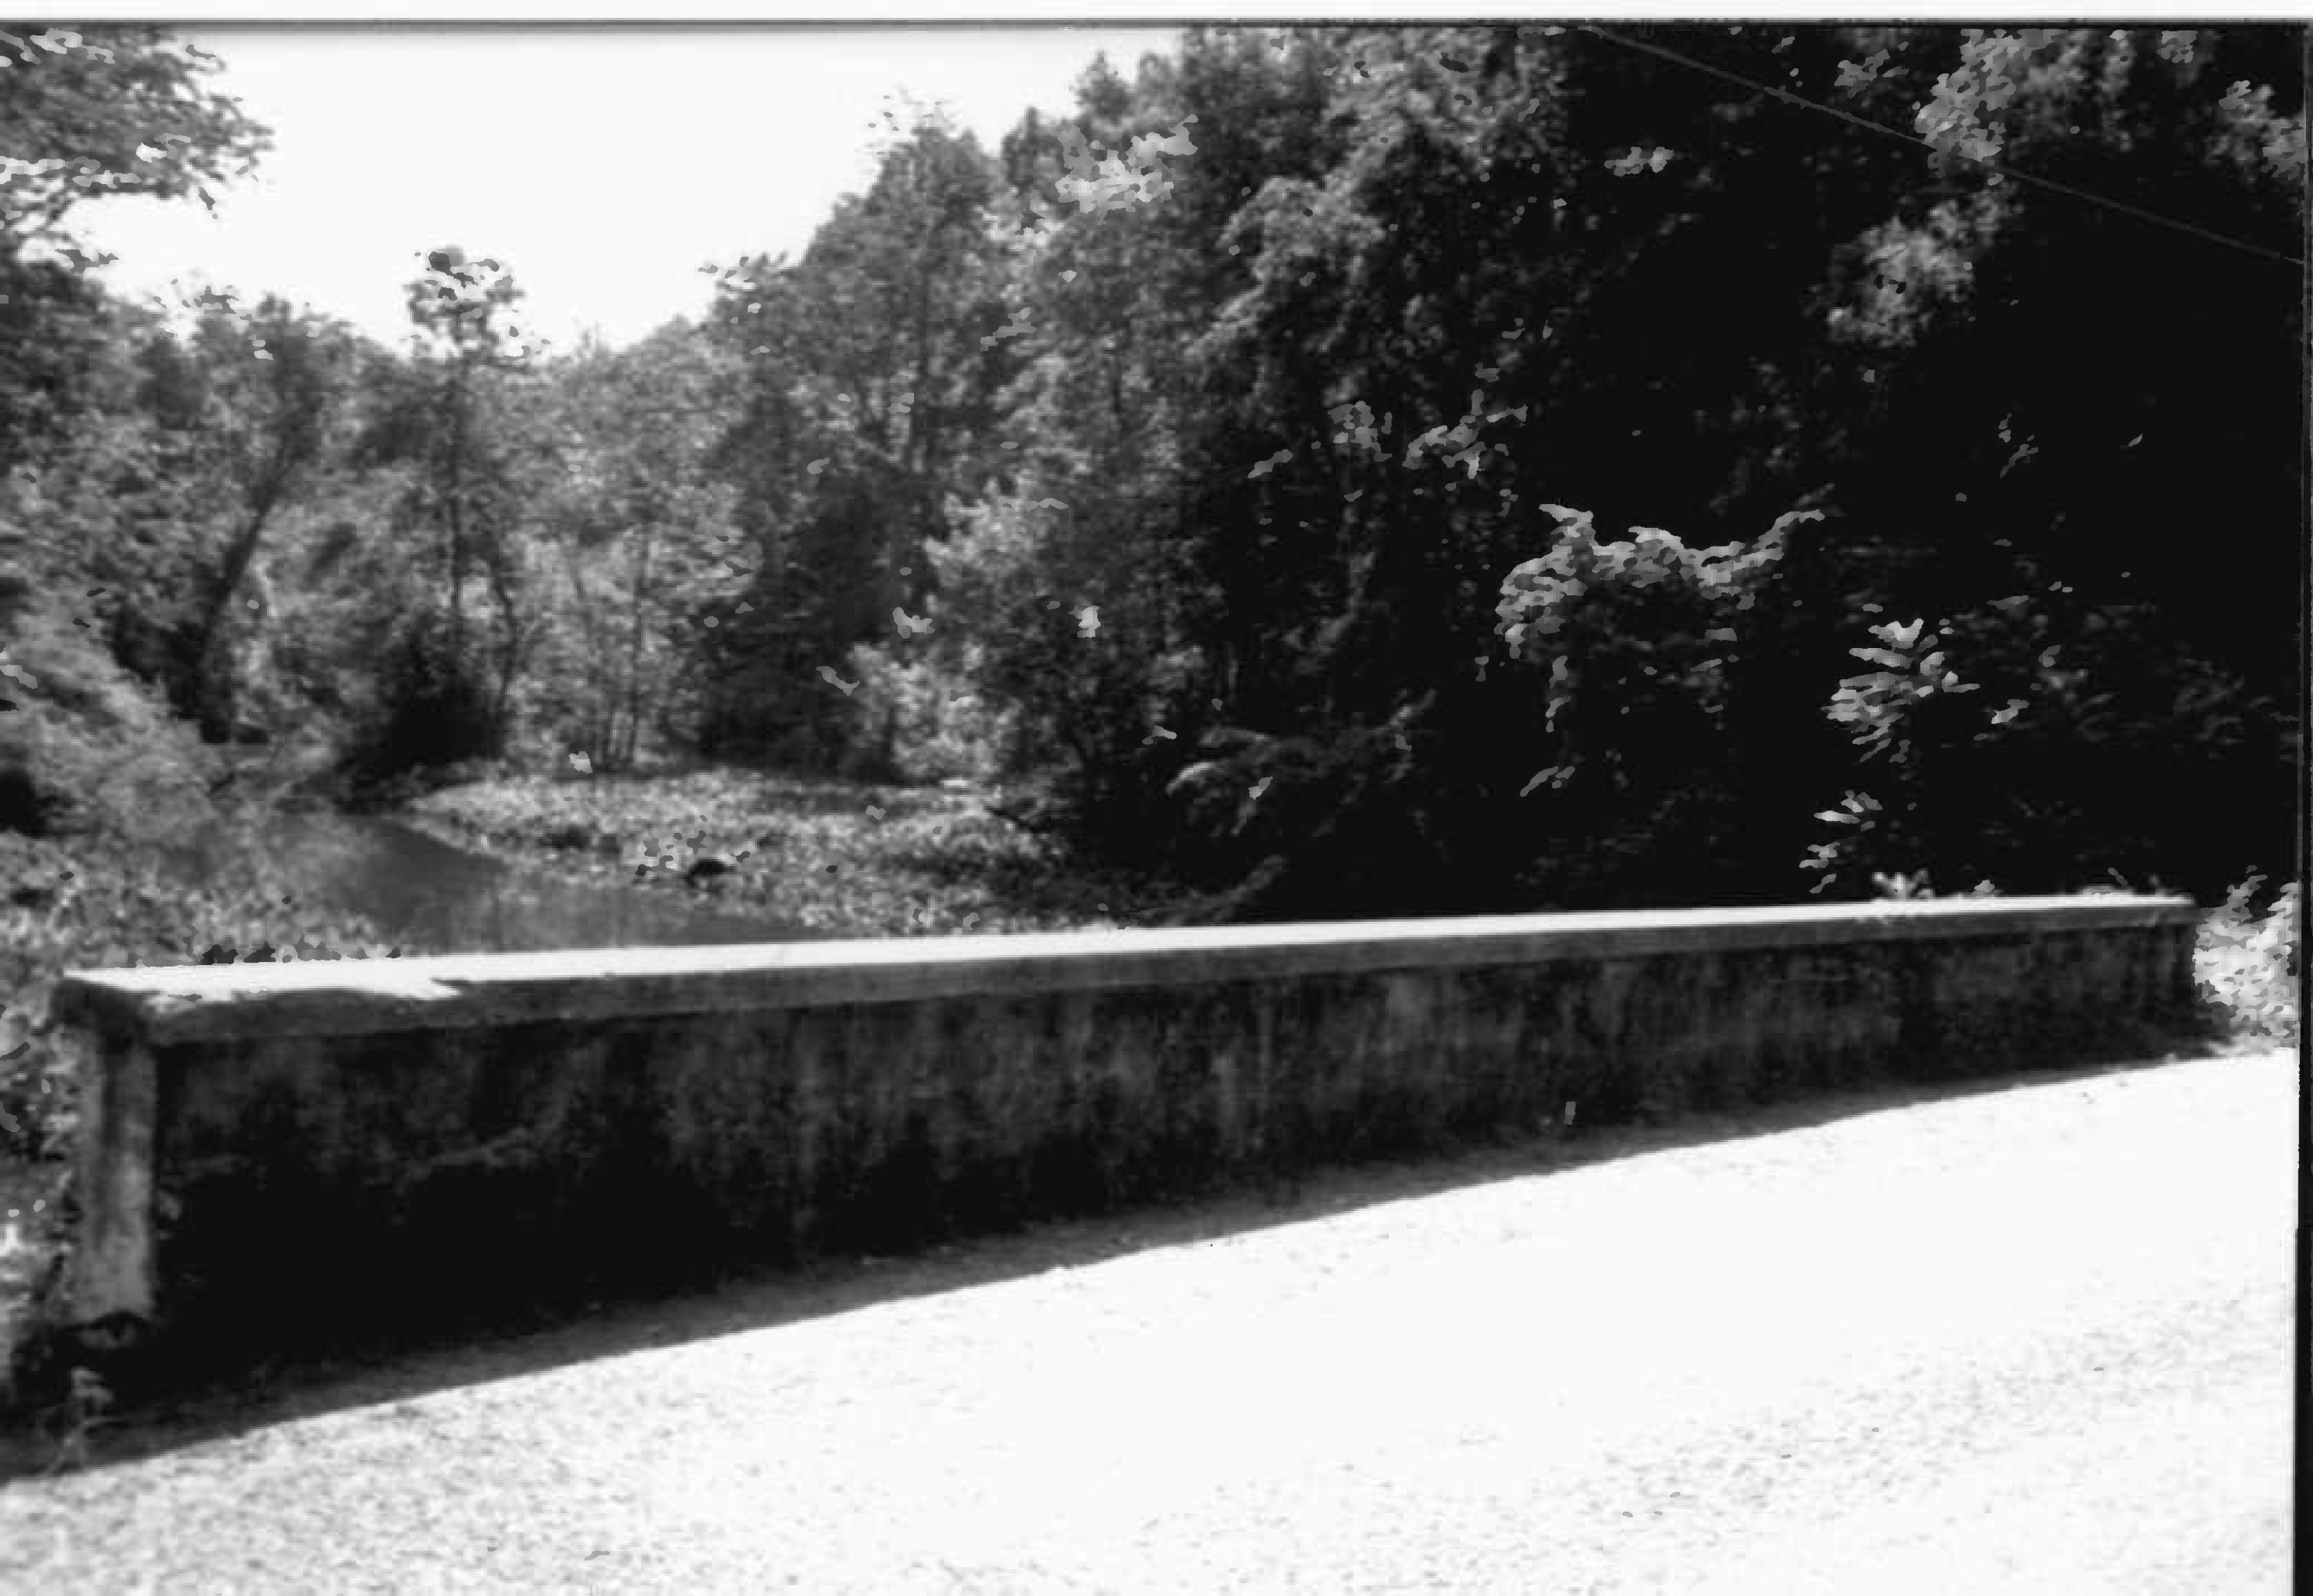
1. CAP-299
2. DOUBLE HILL ROAD OVER WATTS CREEK
3. CAROLINE CO., MD
4. CAROLINE HALL
5. JUNE 1997
6. MD SHPO
7. NORTHEAST VIEW OF NORTH PARADET
8. 6 OF 6
